Navajo Abandoned Uranium Mine

Site Screen Report

Mine Name: Charles Huskon No. 6
Mine ID: 92

August 2011

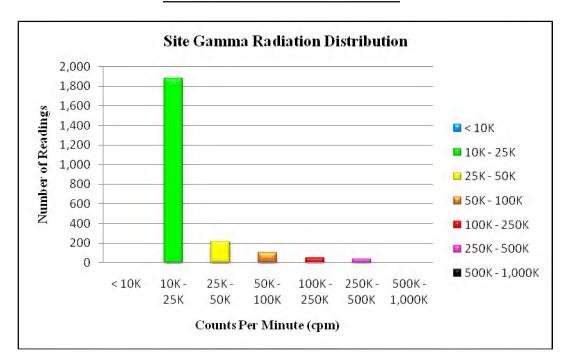
Highest gamma radiation measurement: 381,264 counts per minute (cpm)

Background Average: 14,485cpm **Two Times Background:** 28,970 cpm

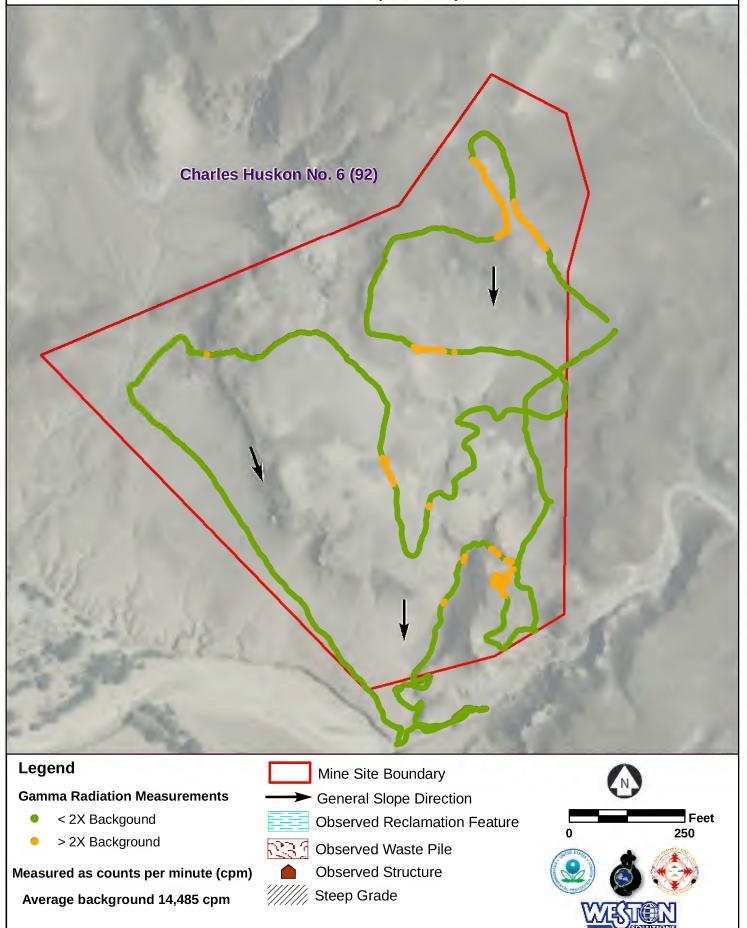
Figure 1 - Gamma Radiation Measurements, Above Two Times Background
Charles Huskon No. 6 (92)
Coalmine Mesa Chapter, Navajo Nation

A total of 2,288 gamma radiation measurements were collected from the mine site, ranging from 11,842 cpm to 381,264 cpm. The measurements are represented in Figures 1 and 2.
